PHASE I REPORT
NATIONAL DAM INSPECTION PROGRAM

Name of Dam: SCS DAM PA-451
State & State No.: PENNSYLVANIA, 64-197
County: WAYNE
Stream: NEVIN CREEK
Date of Inspection: November 6, 1979

SCS DAM PA-451

NDI-ID NO. PA-01031

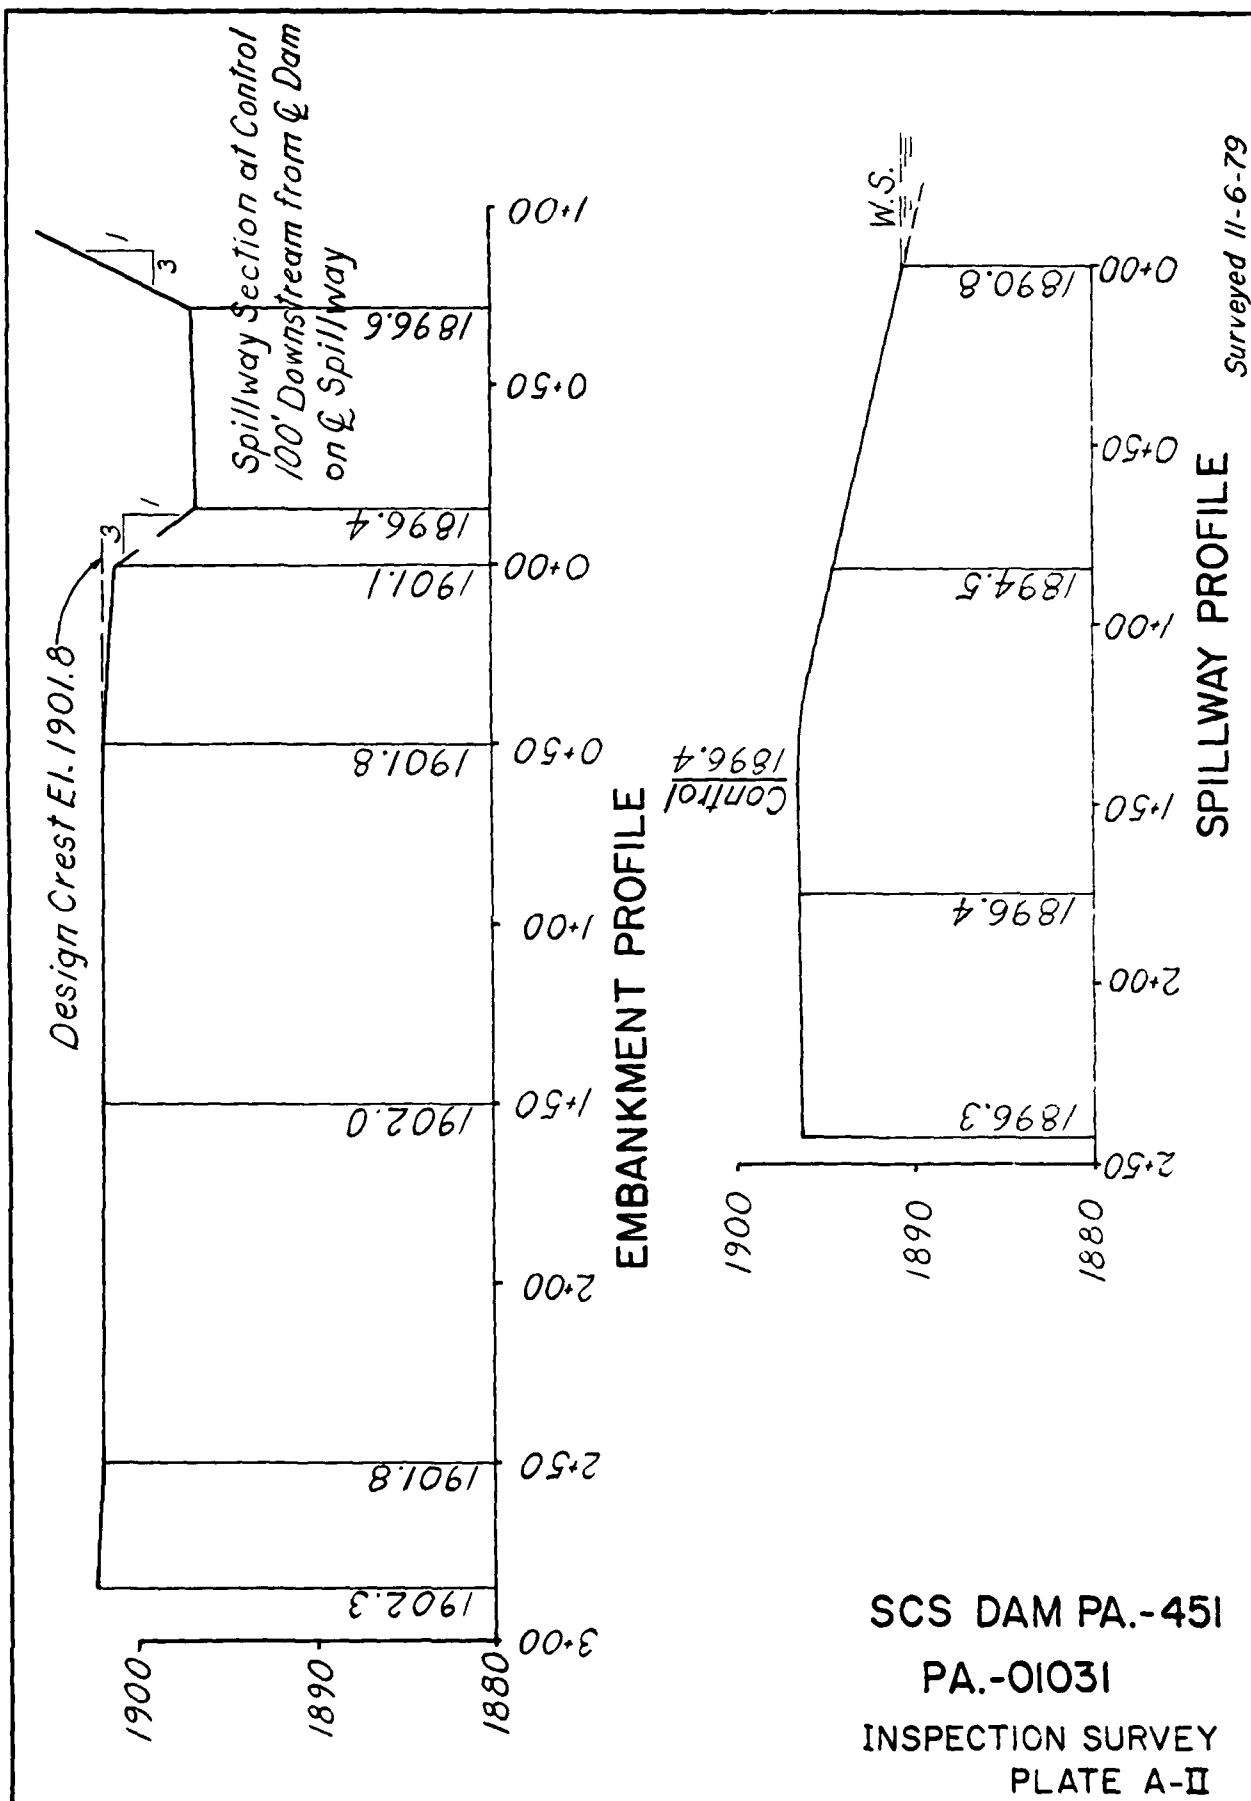
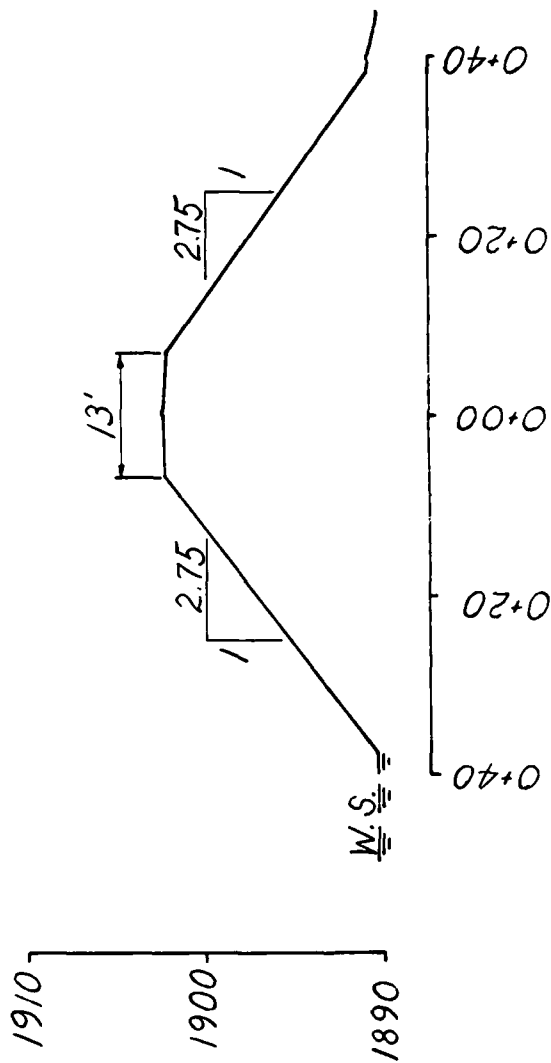
PLATE A-I

The emergency spillway in the right abutment appeared to be in good condition with a good grass mat for erosion protection. The side slopes are stable and the flow of water is directed away from the toe of dam with a spur dike constructed from soil (Appendix A, Plate A-I). The principal spillway was in good condition.

E. RIPRAP FAILURES	No riprap on exposed upstream slope. Appears stone protection below flow line.
F. JUNCTION EMBANKMENT & ABUTMENT OR SPILLWAY	Left abutment is good. Right end of embankment curves and forms left side of emergency. (Plate A-I).
